Manhole Inspection Summary

Manhole # S27M__034MH

Insp Date: **5/7/08 2:34 PM**

Location Address: **876 Carrol St**

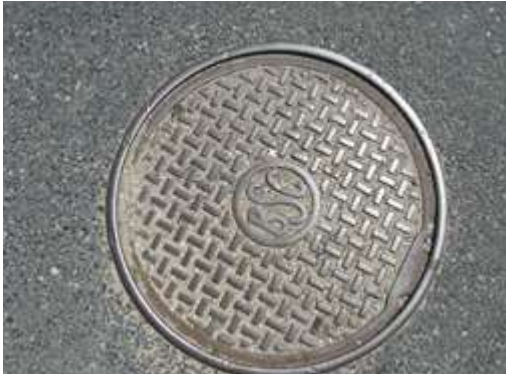
Cover View

Cover Shape: **Circular** Diameter: **26** (in.) Length: **0** (in.) Dist A/B Grade: **0** (in.)
Type: **Sanitary** Condition: **Sound** Cover Material: **Cast Iron**
